**PRELIMINARY ASSESSMENT/  
VISUAL SITE INSPECTION**

**FLINT INK CORPORATION  
MIDDLEBURG HEIGHTS, OHIO  
OHD 000 817 247**

**FINAL REPORT**

Work Assignment No.	:	C05087
EPA Region	:	5
Site No.	:	OHD 000 817 247
Date Prepared	:	October 9, 1992
Contract No.	:	68-W9-0006
PRC No.	:	009-C05087OH2S
Prepared by	:	PRC Environmental Management, Inc. (Deborah E. Lyne)
Contractor Project Manger	:	Shin Ahn
Telephone No.	:	(312) 856-8700
EPA Work Assignment Manager	:	Kevin Pierard
Telephone No.	:	(312) 886-4448

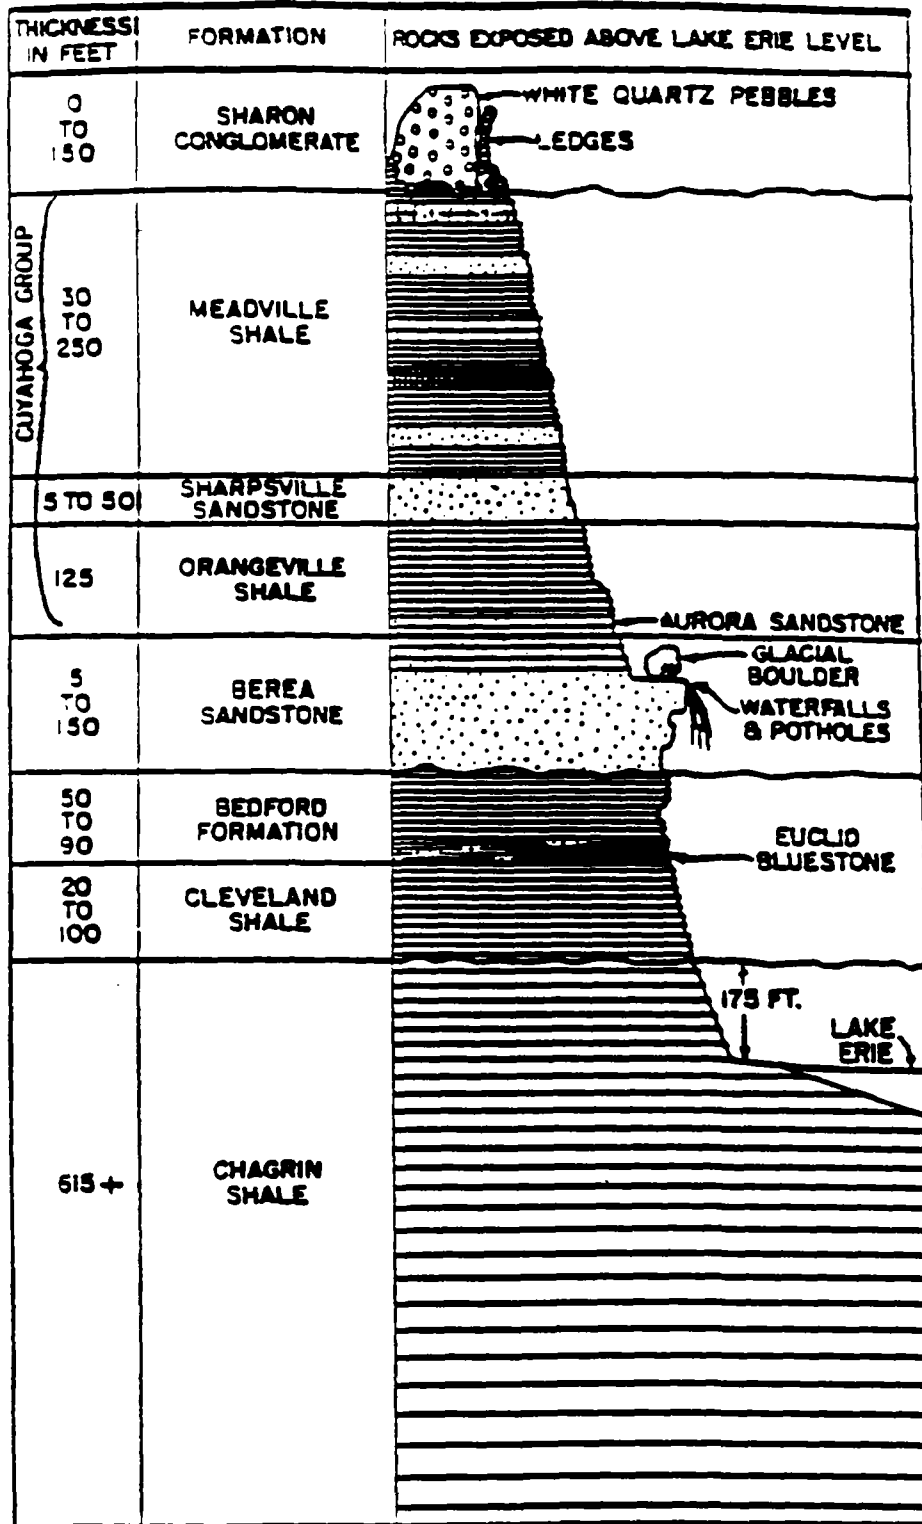
SOURCE: Modified from Williams, 1940

Bedrock in the area of the site is close to the surface. When the former underground storage tank was removed, the tank was found to be resting on bedrock (Flint Ink, 1989). Well log information for wells within 0.5 mile of the site indicate yellow, blue, brown, and sandy clay, gravel, sandstone, and red shale in the soils near the facility (Ohio Department of Natural Resources, 1955-1964).

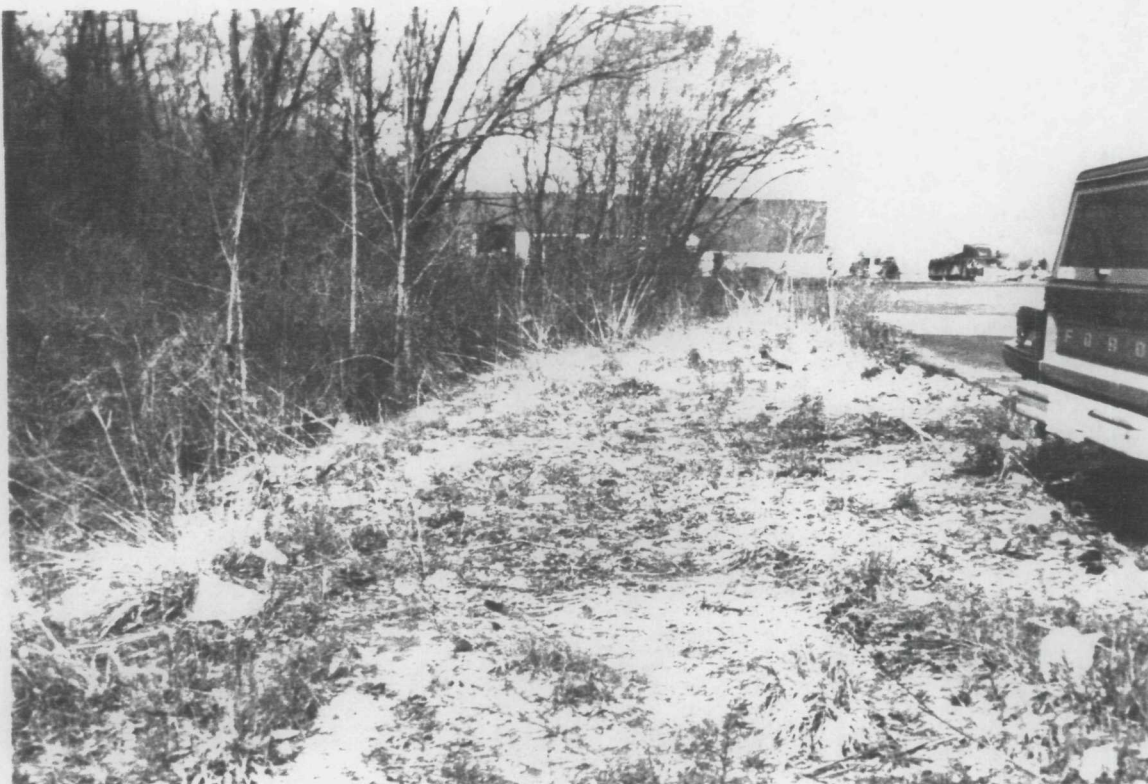
**Photograph No.** 1  
**Orientation:** West  
**Description:** Location of former underground storage tank

**Location:** SWMU 5  
**Date:** April 29, 1992

History of Documented Releases: Although no releases from this SWMU have been documented, during the tank removal, ground water contaminated with diesel fuel was noted in the area of the excavation.

PRC recommends that the owner of the facility, Harsax, Inc., undertake ground- and surface-water sampling in the area of the industrial park to determine whether there is further diesel fuel contamination of ground water, the unnamed stream that runs behind the facility, or the adjacent wetlands to the west of the property and to identify probable source(s) of the contamination.

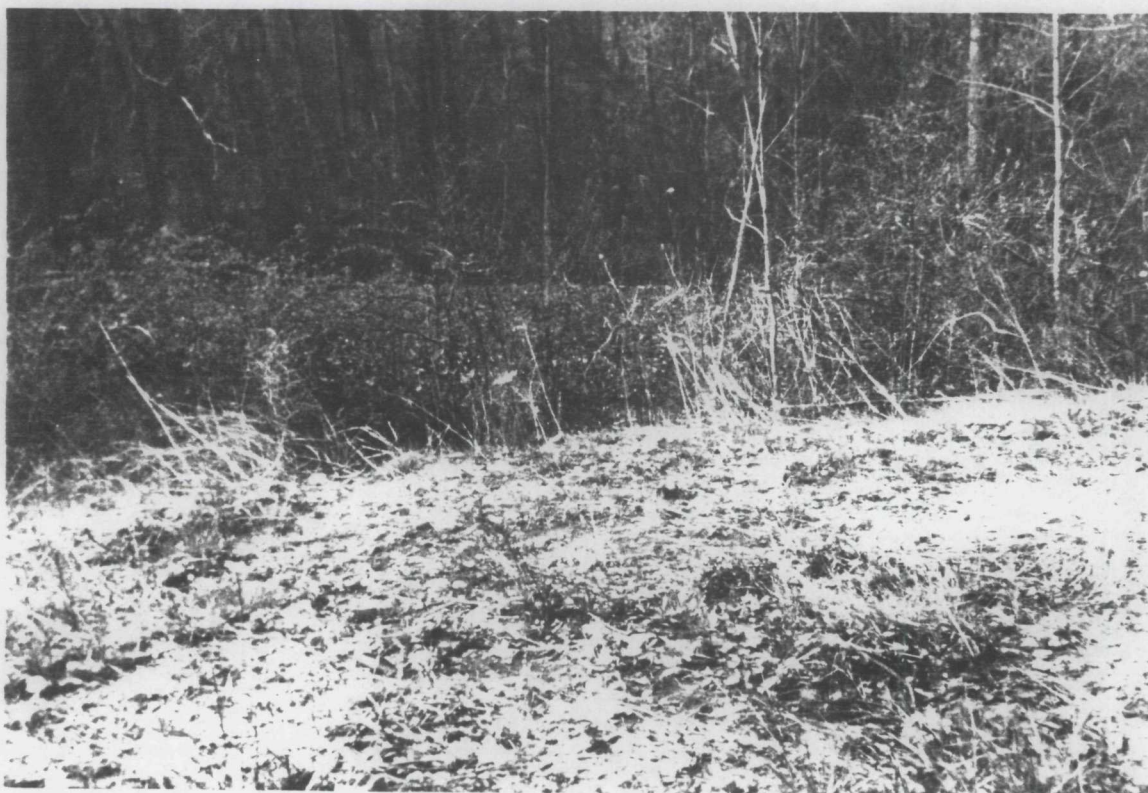
**Photograph No.** 2  
**Orientation:** South  
**Description:** Location of former underground storage tank

**Location:** SWMU 5  
**Date:** April 29, 1992

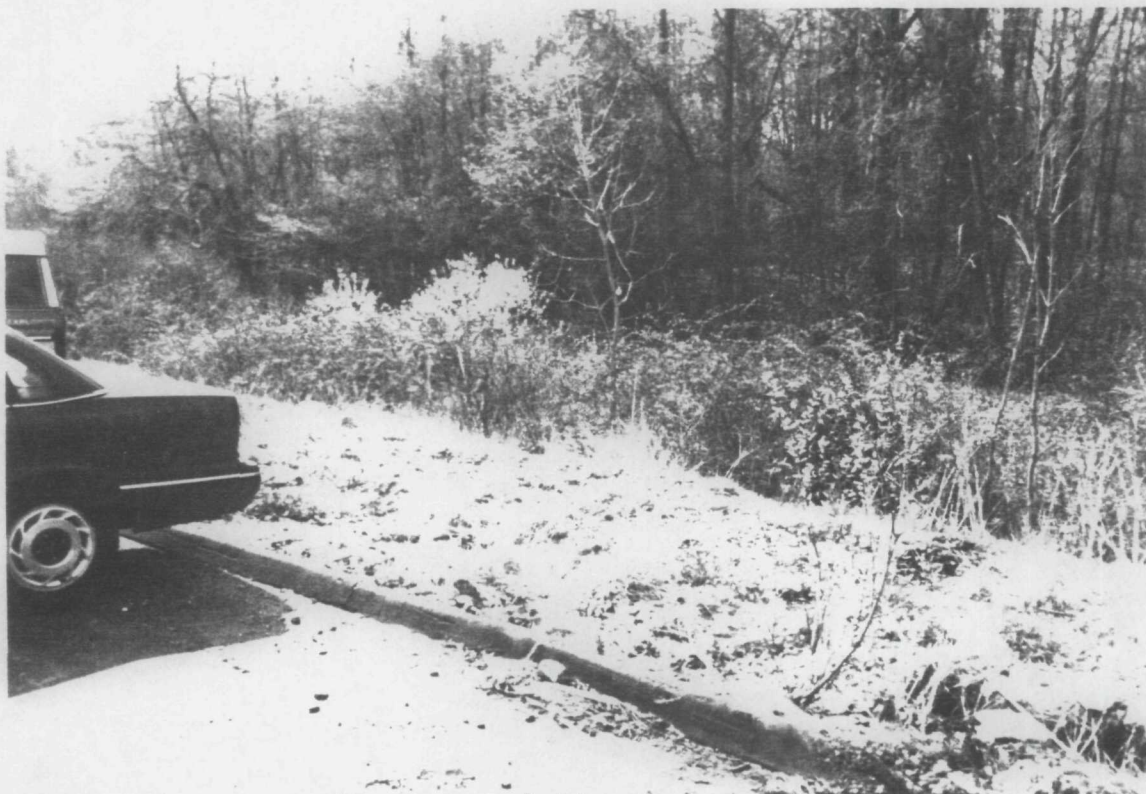
**Photograph No.** 3  
**Orientation:** East  
**Description:** Location of former underground storage tank

**Location:** SWMU 5  
**Date:** April 29, 1992

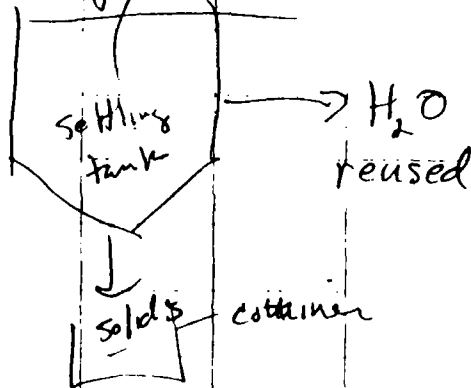
device in right see Figure below. Dust collector is adjacent to settling tank.

H<sub>2</sub>O pumped to settling tank

Tub Washer
